LEVEL 2 REPLACEMENT RESERVE REPORT FY 2020 DUFIEF HOMES ASSOCIATION

REPLACEMENT RESERVE REPORT

DUFIEF HOMES ASSOCIATION

NORTH POTOMAC, MARYLAND
August 24, 2020
Board Approved February 16, 2021

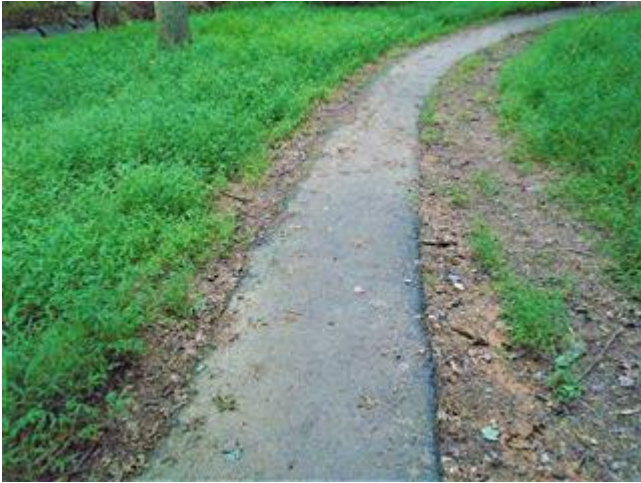
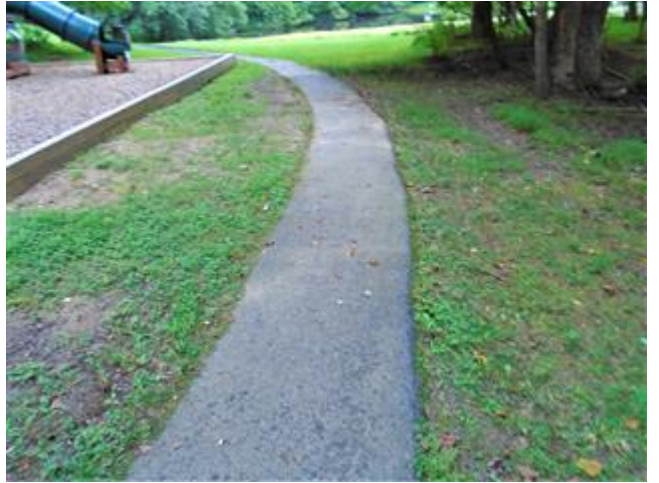
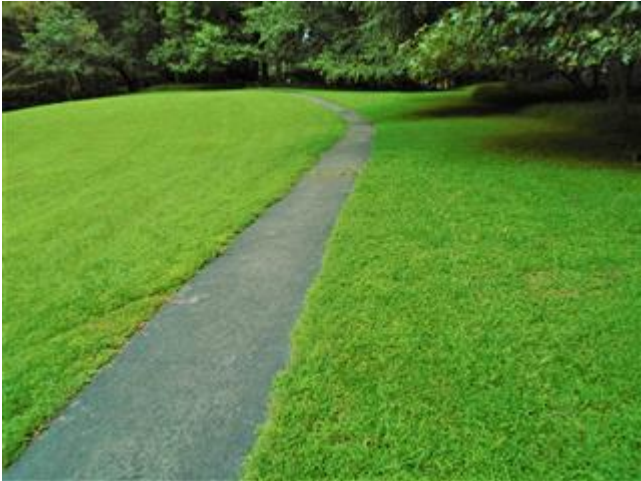
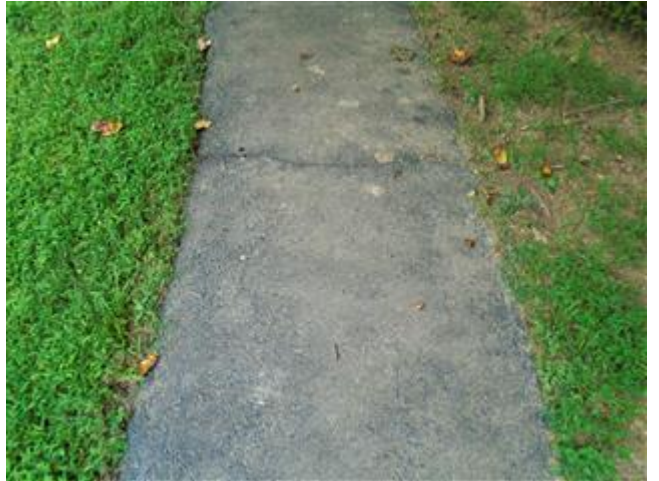
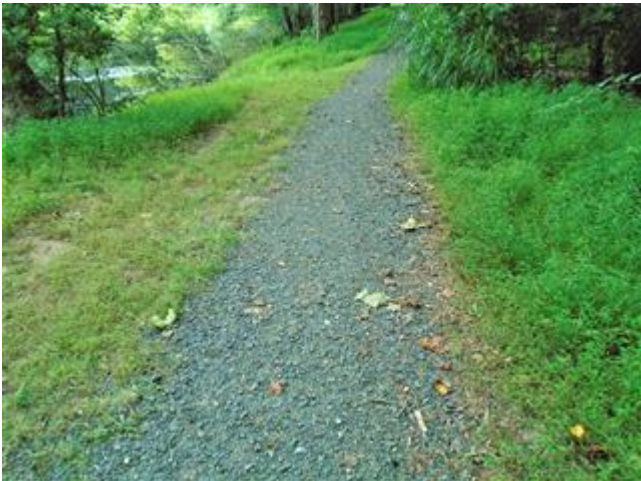
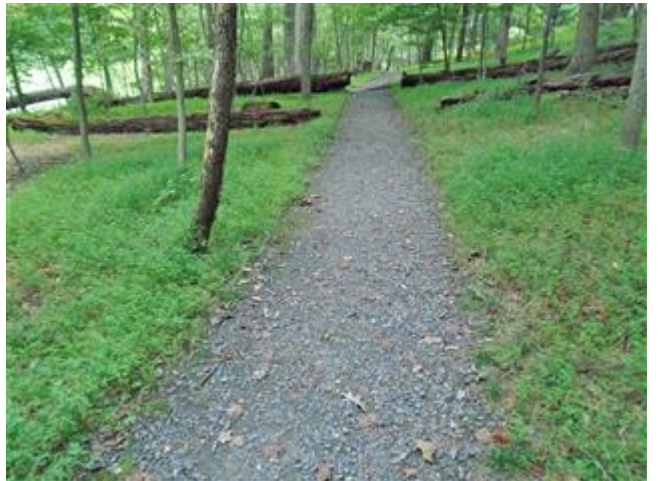
Crushed Stone Pathways. The Association maintains an inventory of approximately 3,000 square feet of crushed stone pathways that partially surround the stormwater pond. The crushed stone was partially replenished since the last study. In addition, the stone was applied as a topcoat to the stairways leading from Coles Chance Road, that stone has been depleted, making for uneven step areas. The gravel should be monitored and replaced periodically.

Concrete Pavers. The Association maintains an inventory of approximately 575 square feet of open-cell concrete pavers. These provide vehicular access paths from Cole Chase Road leading to asphalt pathway, tot lot, and stormwater pond. The Association is extended the path since the 2015 study. An allowance for replacement and or repair of pavers has been programmed in the analysis.

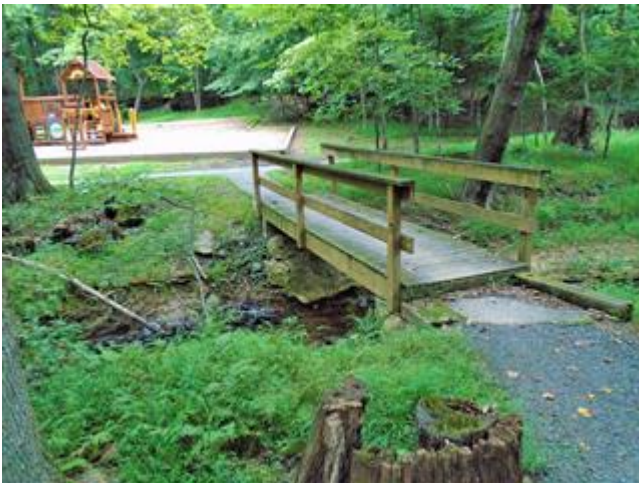
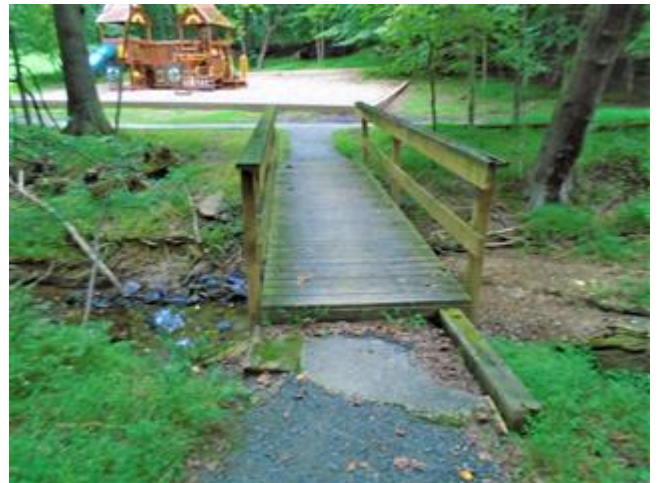
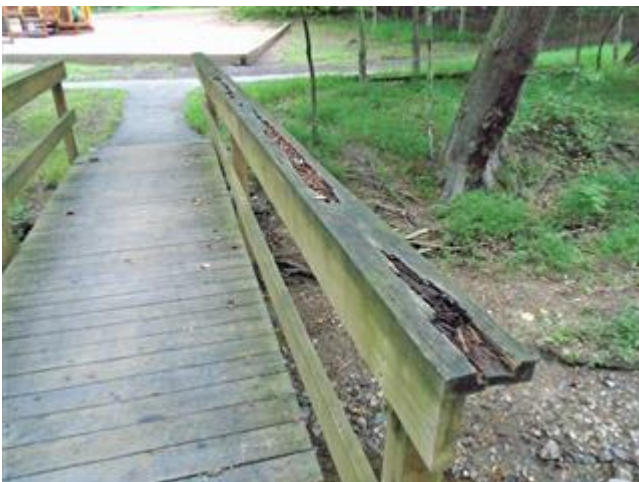
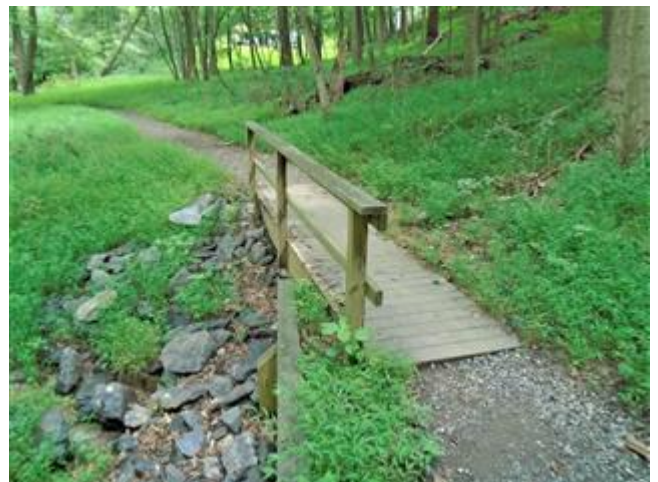
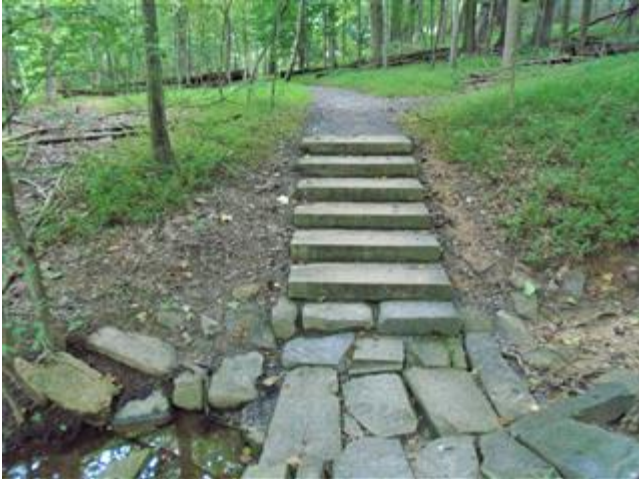
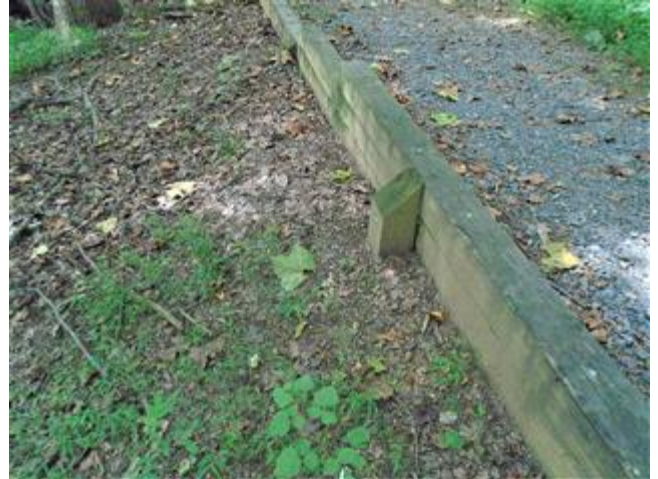
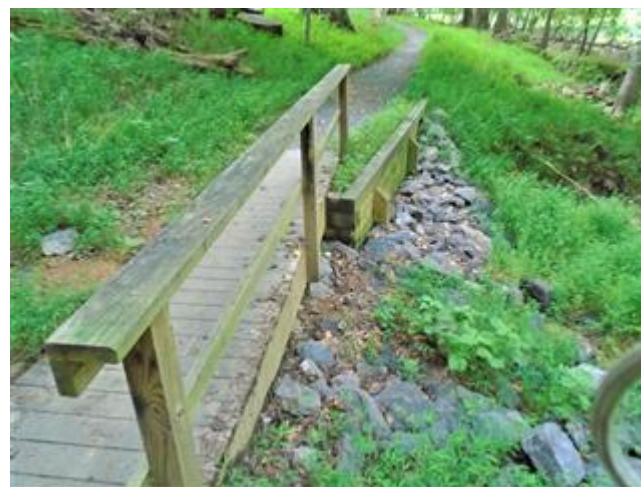
Retaining Wall. The Association maintains a single wood retaining wall adjacent to one of the pedestrian bridges along the pond/park pathway. The retaining wall is in good overall condition.

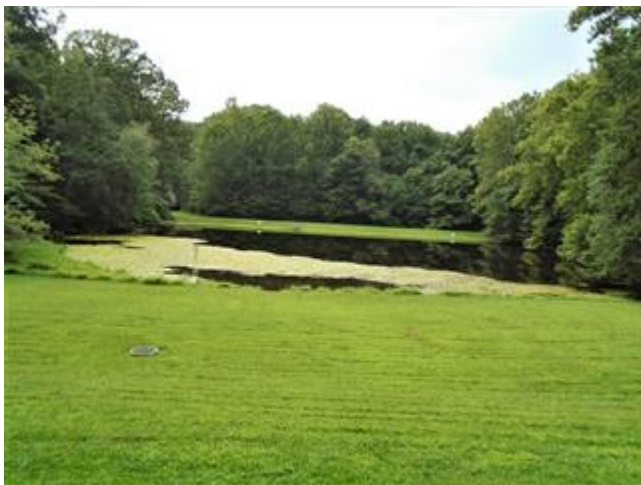
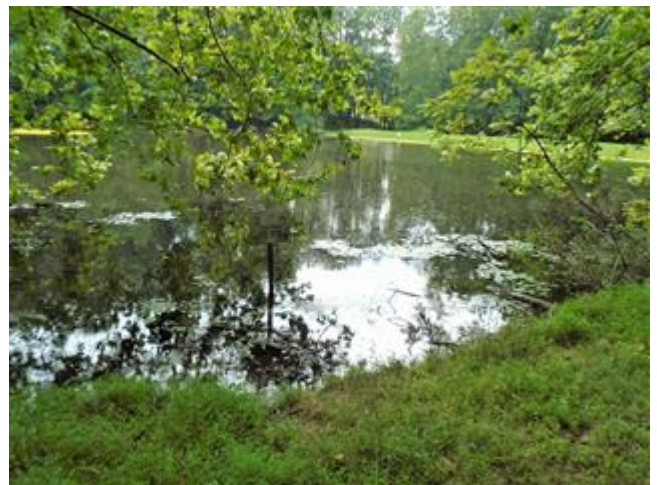
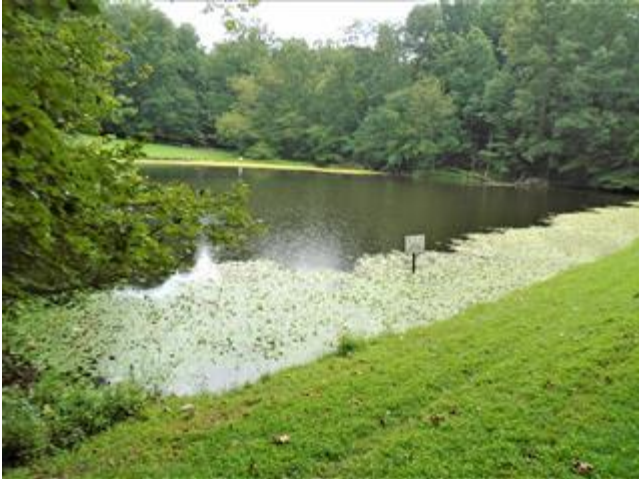
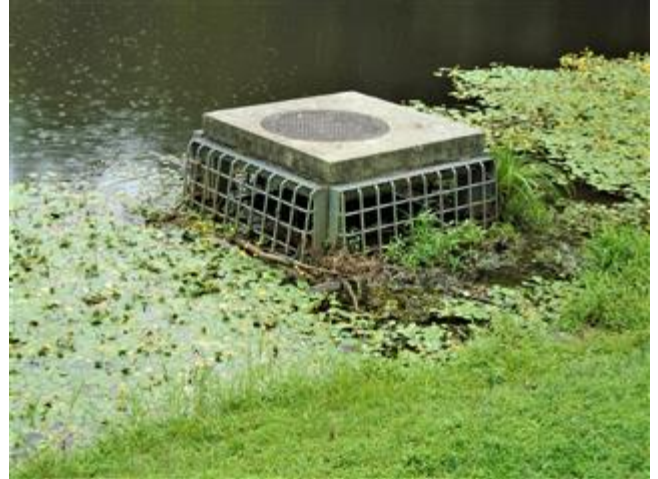
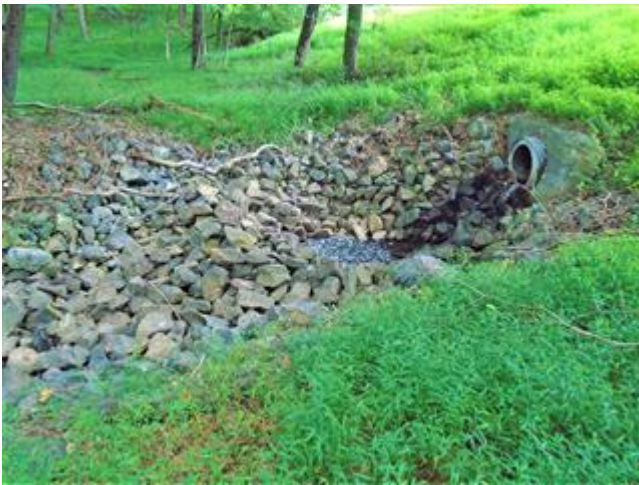
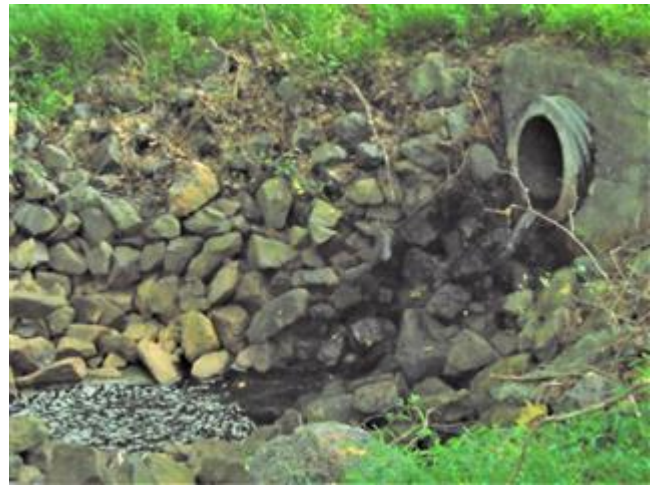
Vegetation Management. Grass is usually used around and in storage, ponds to prevent erosion and to filter sediment. The grass near the pond should not be over-fertilized, or the excessive nutrients will be washed into the pond and contribute to the growth of algae. Grass should be cut no shorter than 6-8 inches.

Please note that the periodic removal of overgrown vegetation from the pond is considered a maintenance activity and has not been reserved for or included in this study.

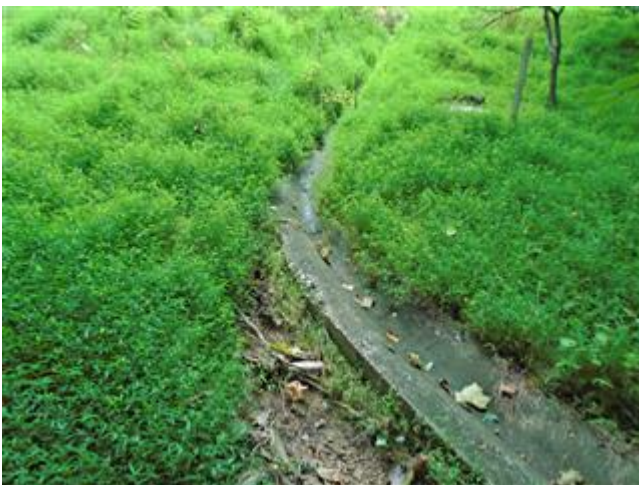
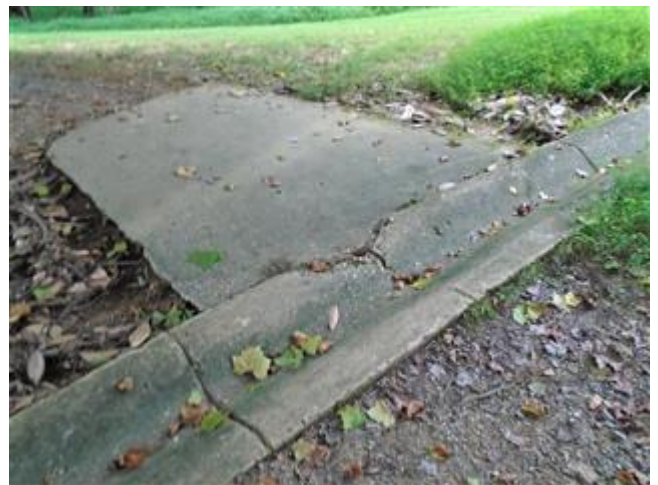
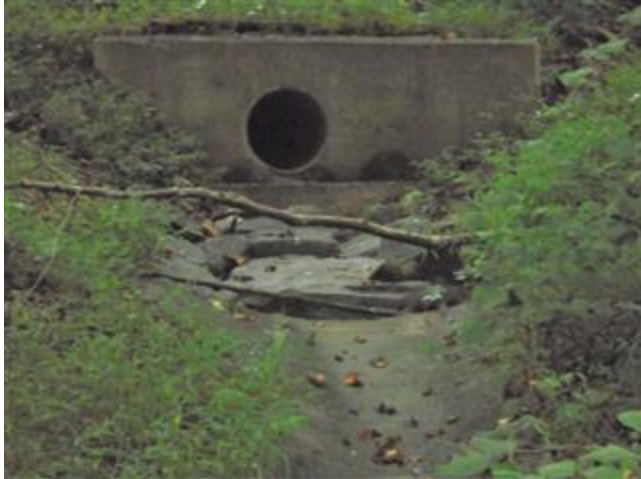
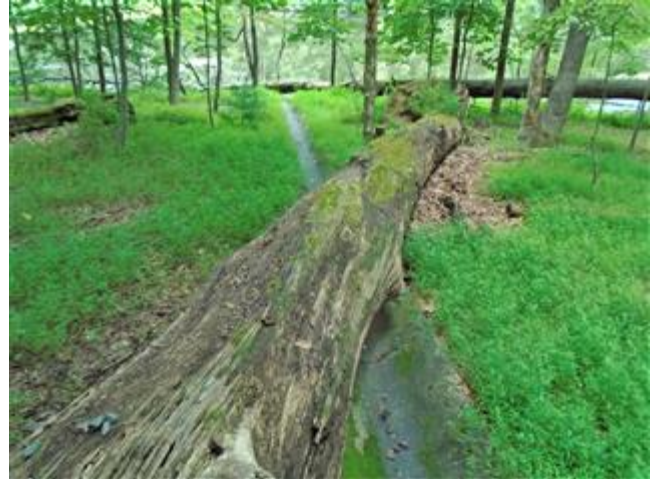
Concrete Culverts. The Association maintains three concrete culverts that channel street and surface stormwater into the pond. The culverts should be periodically inspected and cleared of debris. The terminal point of the culverts should be stabilized with stone rip-rap to mitigate erosion of pond banks. An allowance for periodic repairs of culverts has been programmed in the analysis.

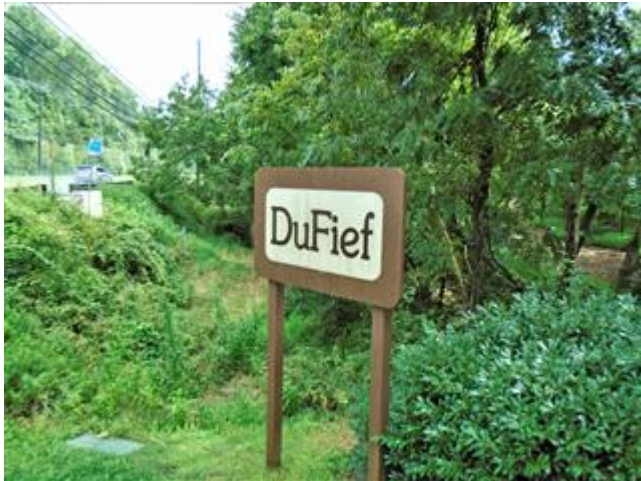
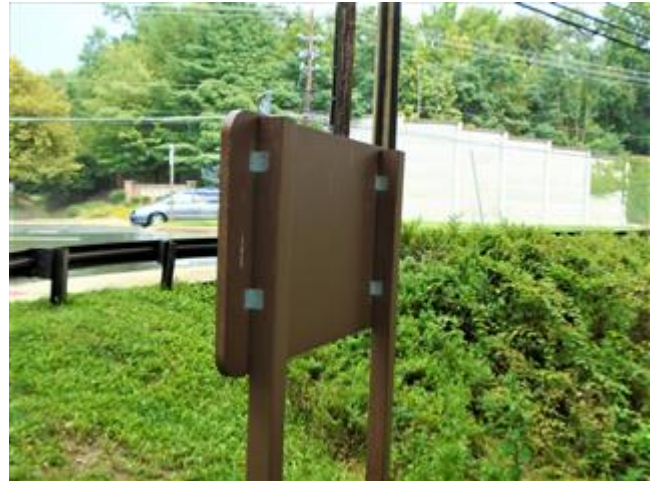
Entry Signage. The Association maintains two carved signs at Dufief Rd and Darnestown Road, and a painted wood sign at the pond/park area at Coles Chance Road. The latter has been replaced in the last five years. The signs are in good overall condition.

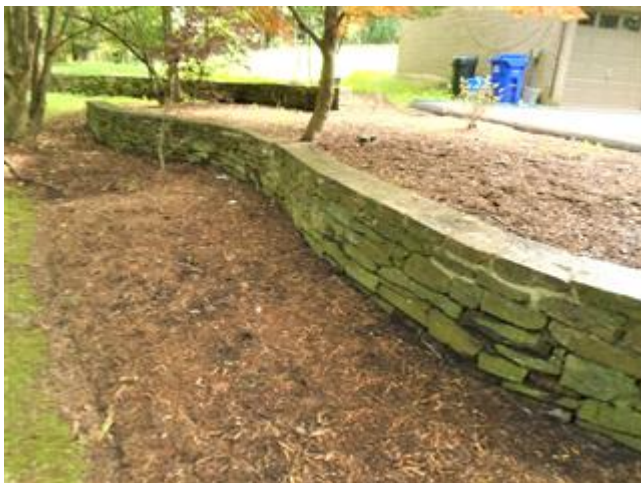
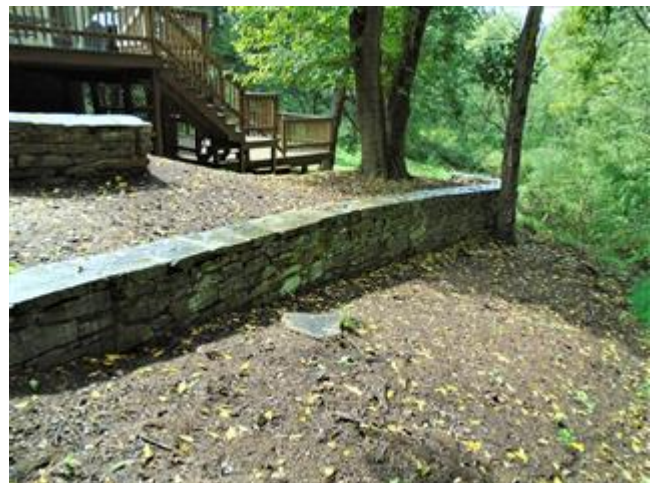
Stone Retaining Walls. The Association maintains a series of stacked stone retaining walls at the entrance of the community at Dufief Road and Darnestown Road. Minor repairs have been performed on the walls in the last five years. There were no significant issues observed at the time of site inspection. An allowance for periodic repairs has been programmed in the analysis.

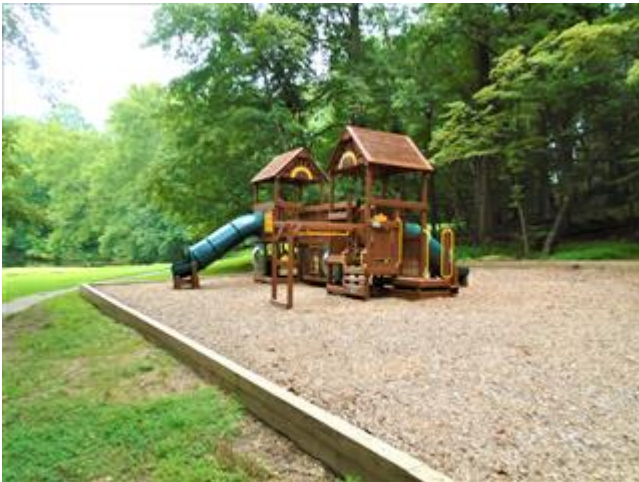
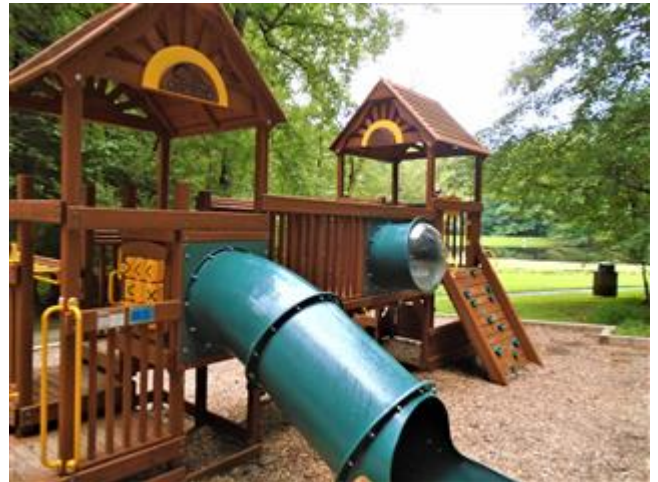
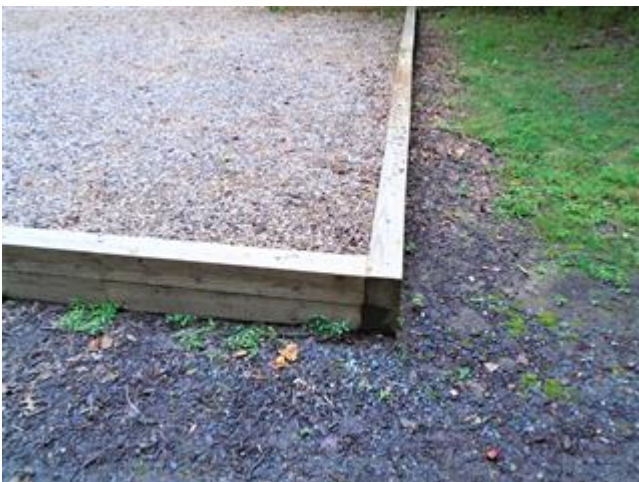
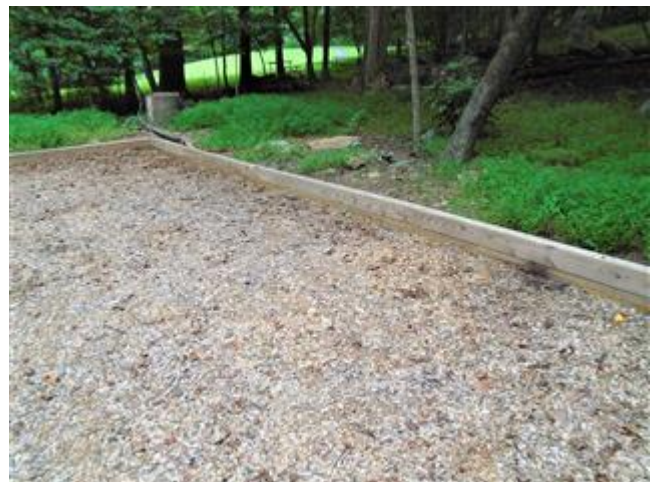
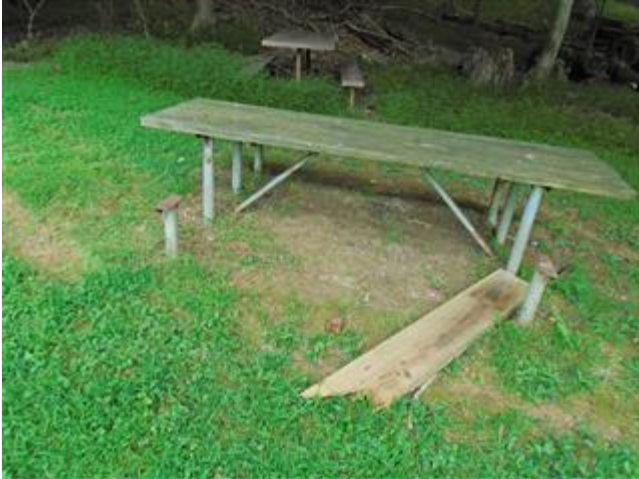
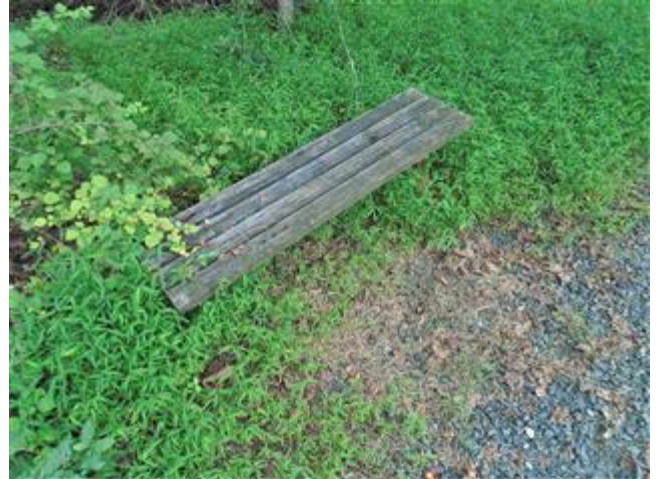
Tot Lots. The community maintains a tot lot located in the pond/park area of the community. The tot lot includes a play structure, wood borders, and a wood chip surface. The facilities were recently replaced and in good condition. The wood chip surface appears to be adequate.

Picnic Table & Benches. In addition to the playground, the parking area contains four picnic tables and several benches. Three of the tables and the benches are in poor condition.
